Towards predictability of bridge health

J. Moore, R. Glencross-Grant, S. Mahini & R.Patterson

Engineers Australia, Regional Convention - Armidale

16th - 18th September 2011

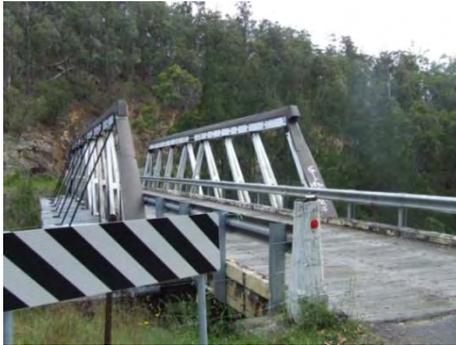
The bridge over the Styx River (Figure 1) is a Type C (Allan) truss, which was erected in 1899 (Glencross-Grant 2009). Horton's Creek Bridge (Figure 2) is representative of many bridges built in the inter-war period and carries traffic plying the New England Tableland with the North Coast. Munsie's Bridge over Salisbury Waters (Figure 3) is another one during this period, being built in

Figure 1: Bridge over Styx River

Bridges in Figures 1 to 4 were chosen to demonstrate the diversity and versatility of rural timber bridges. The history and maintenance records of many of the earlier bridges are not readily available since their management has changed numerous during their long lives. Many bridges that were initially owned by the Public Works Department (PWD) were passed on to subsequent road authorities (Main Roads Board, Dept of Main Roads and latterly Roads and Traffic Authority) and then to relevant local councils. In Armidale, for example, further changes in ownership have occurred as councils have been amalgamated; Dumaresq Council and Armidale Council amalgamated in 2000 to become the Armidale Dumaresq Council. Such amalgamations are commonly associated with a reduction in workforce size; a reduction in operational and record space; and often a loss of, or

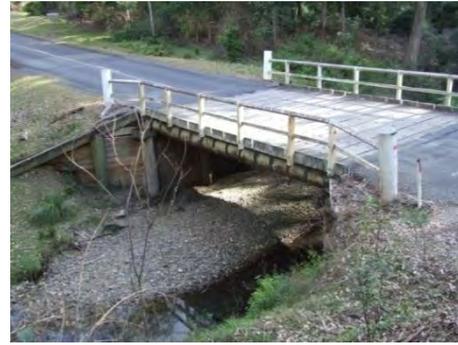
**Figure 2: Horton's Creek Bridge,
Armidale-Grafton Road**

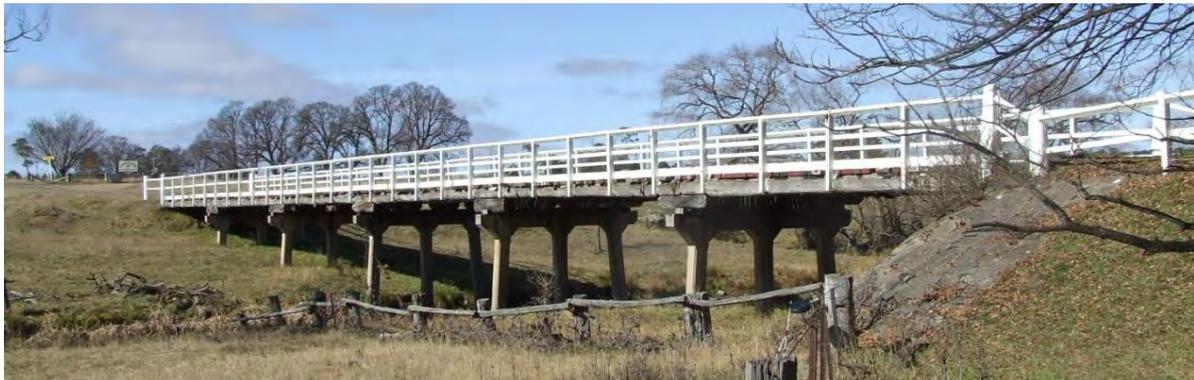
1938. This bridge services an agriculturally diverse area of wool and cattle production on the New England Tableland. A recent replacement of a multi-span timber bridge is the Leslie's Bridge (Figure 4) on the Walcha/Gloucester Road. This bridge was constructed using round timber girders with a composite concrete deck, supported on round steel piles.

Figure 3: Munsie's Bridge over Salisbury Waters, east of Uralla

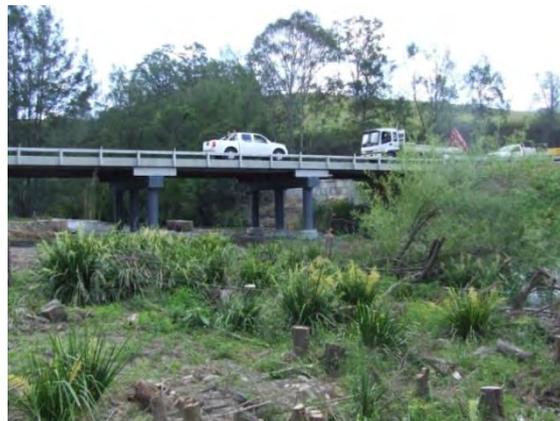
Figure 4: Leslie's Bridge replacement, Thunderbolts Way over the Manning River (Walcha-Gloucester)

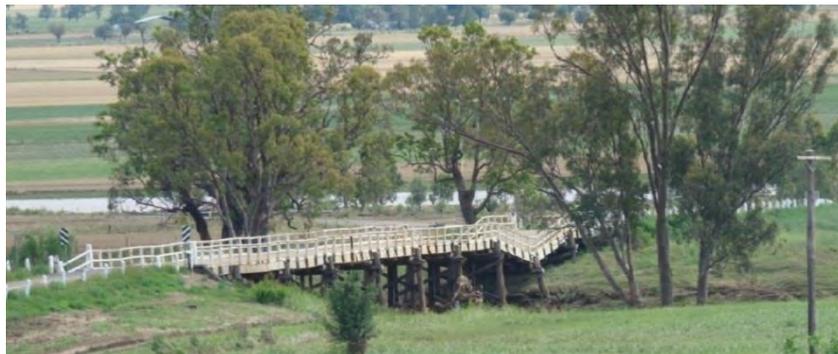
Figure 5: Somerton Bridge west of Tamworth, which connects Somerton village to Oxley Highway

The substructure failure of the Somerton Bridge (Figure 5) involved the subsidence of the piers leading to loss of deck stability. In such a situation, if the last vehicle to cross the structure does so

As can be seen from the examples (Figures 1 – 4), each structure is different, and a ‘one-size-fits-all’ approach is difficult to manage and often does not work. However, they all have some common characteristics. There are also a variety of failure modes, which can be grouped into substructure failure and superstructure failure. An example of a substructure failure is given in Figure 5 and one of superstructure failure in Figure 6.

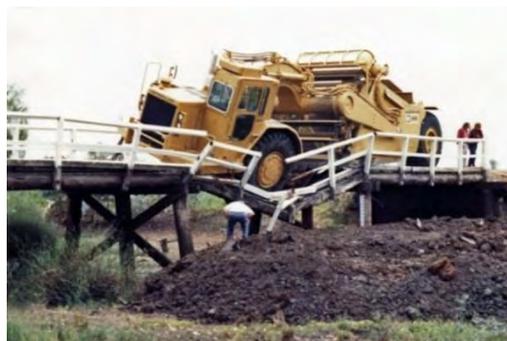
Figure 6: Overload -shearing first deck plant and then fracturing the kerb girder

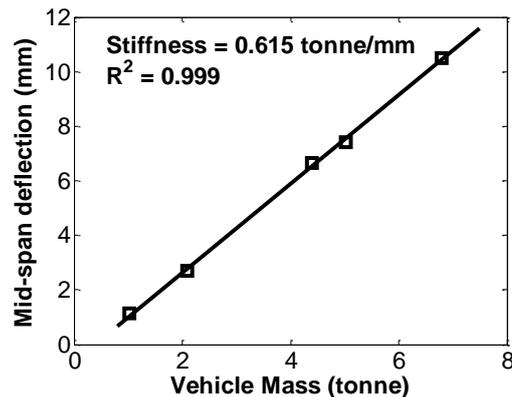
Simply by measuring deflection several factors can be determined. Firstly, vehicle mass can be estimated as shown by Figure 7. More importantly, when a vehicle of known mass traverses the bridge, comparisons over time can be made and the health of the girders implied by the increased deflection for that known mass. This method would allow councils to proof-load with a truck of known mass, at say monthly or quarterly intervals, and build a set of deflection data for each timber bridge in their local government area. The actual cost to the council could be as low as a few person-hours per bridge for each monitoring session. Secondly, from the slope of the curve in Figure 7, the girder stiffness can be inferred; any small, but significant change in temporal stiffness is indicative of degradation. Thirdly, larger significant changes in effective stiffness can be indicative of degradation to the support region of the girder and headstocks.

Figure 7: Mid-span deflection plotted against vehicle mass (tonnes) for static load test of study bridge

Data are recorded for each vehicle traversing the bridge and the deflection, which is proportional to the load, is measured and recorded in real time. Not only is the mass of the vehicle inferred by the deflection, but vehicle counts are recorded in real time and large heavily laden axles can be identified at a particular time and temporal variation of vehicle movement can be monitored. These larger events may coincide with the local school bus, stock carriers heading to saleyards, or other identified road users. As an example, a measurement system read to a resolution of 0.5 mm has been used to identify the deflection under load over a load range of 1-7 tonnes with a standard error of 0.14 mm and a coefficient of determination of 0.999 (Figure 7). Measurement resolution of 0.5 mm is thus sufficient to provide stiffness data of reasonable accuracy.

Figure 8 shows the optical source mounted on a rigid tripod on firm bank under the bridge, such as would be used for measurement over a day where the instrument was attended at all times. For field calibration, a graduated chart target is attached to a girder and the position of the optical source image on the chart adjusted to zero. Data can be gathered statically by loading the bridge with a vehicle of known mass and recording the movement of the laser image observed on the chart. If dynamic measurements are required, then the movements of the laser image on the chart, caused by a moving vehicle, can be recorded with a high speed camera (see Figure 8). By interpretation of the video images, the range of deflections for a particular girder can be developed as shown in Figure 7. These

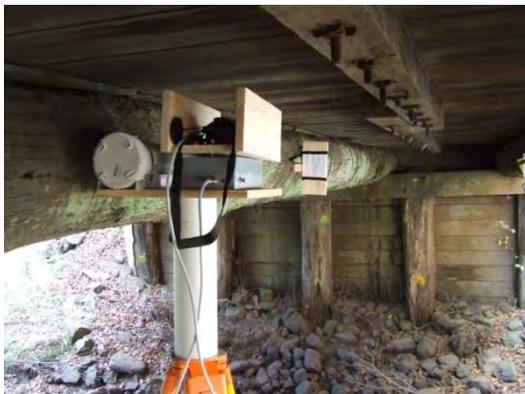
Figure 8: Optical source, high speed camera and graduated chart target

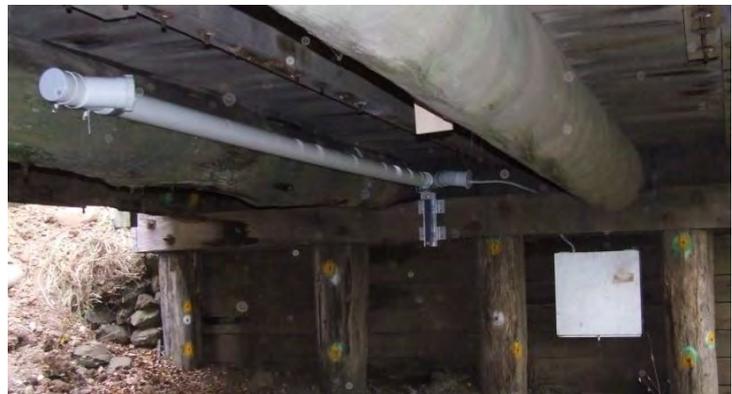
The field version of the laser device is encapsulated in a 100 mm PVC tube, housing the laser at one end and the target at the other end. The laser end of the tube is secured to the headstock of the bridge where minimal vibration will occur. The distal end of the tube is secured near the centre of the girder (see Figure 9). An on-site adjustment is required to set the quiescent position of the laser, but this is simply a screw adjustment.

Figure 9: Under-bridge view of field version of laser device

data are then used as calibration of an enclosed system that can be mounted more permanently on one of the girders and connected to a data recorder (refer Figure 9).
